Shooting Cracks at Bridger Bowl

Bridger Range, 2019-10-31

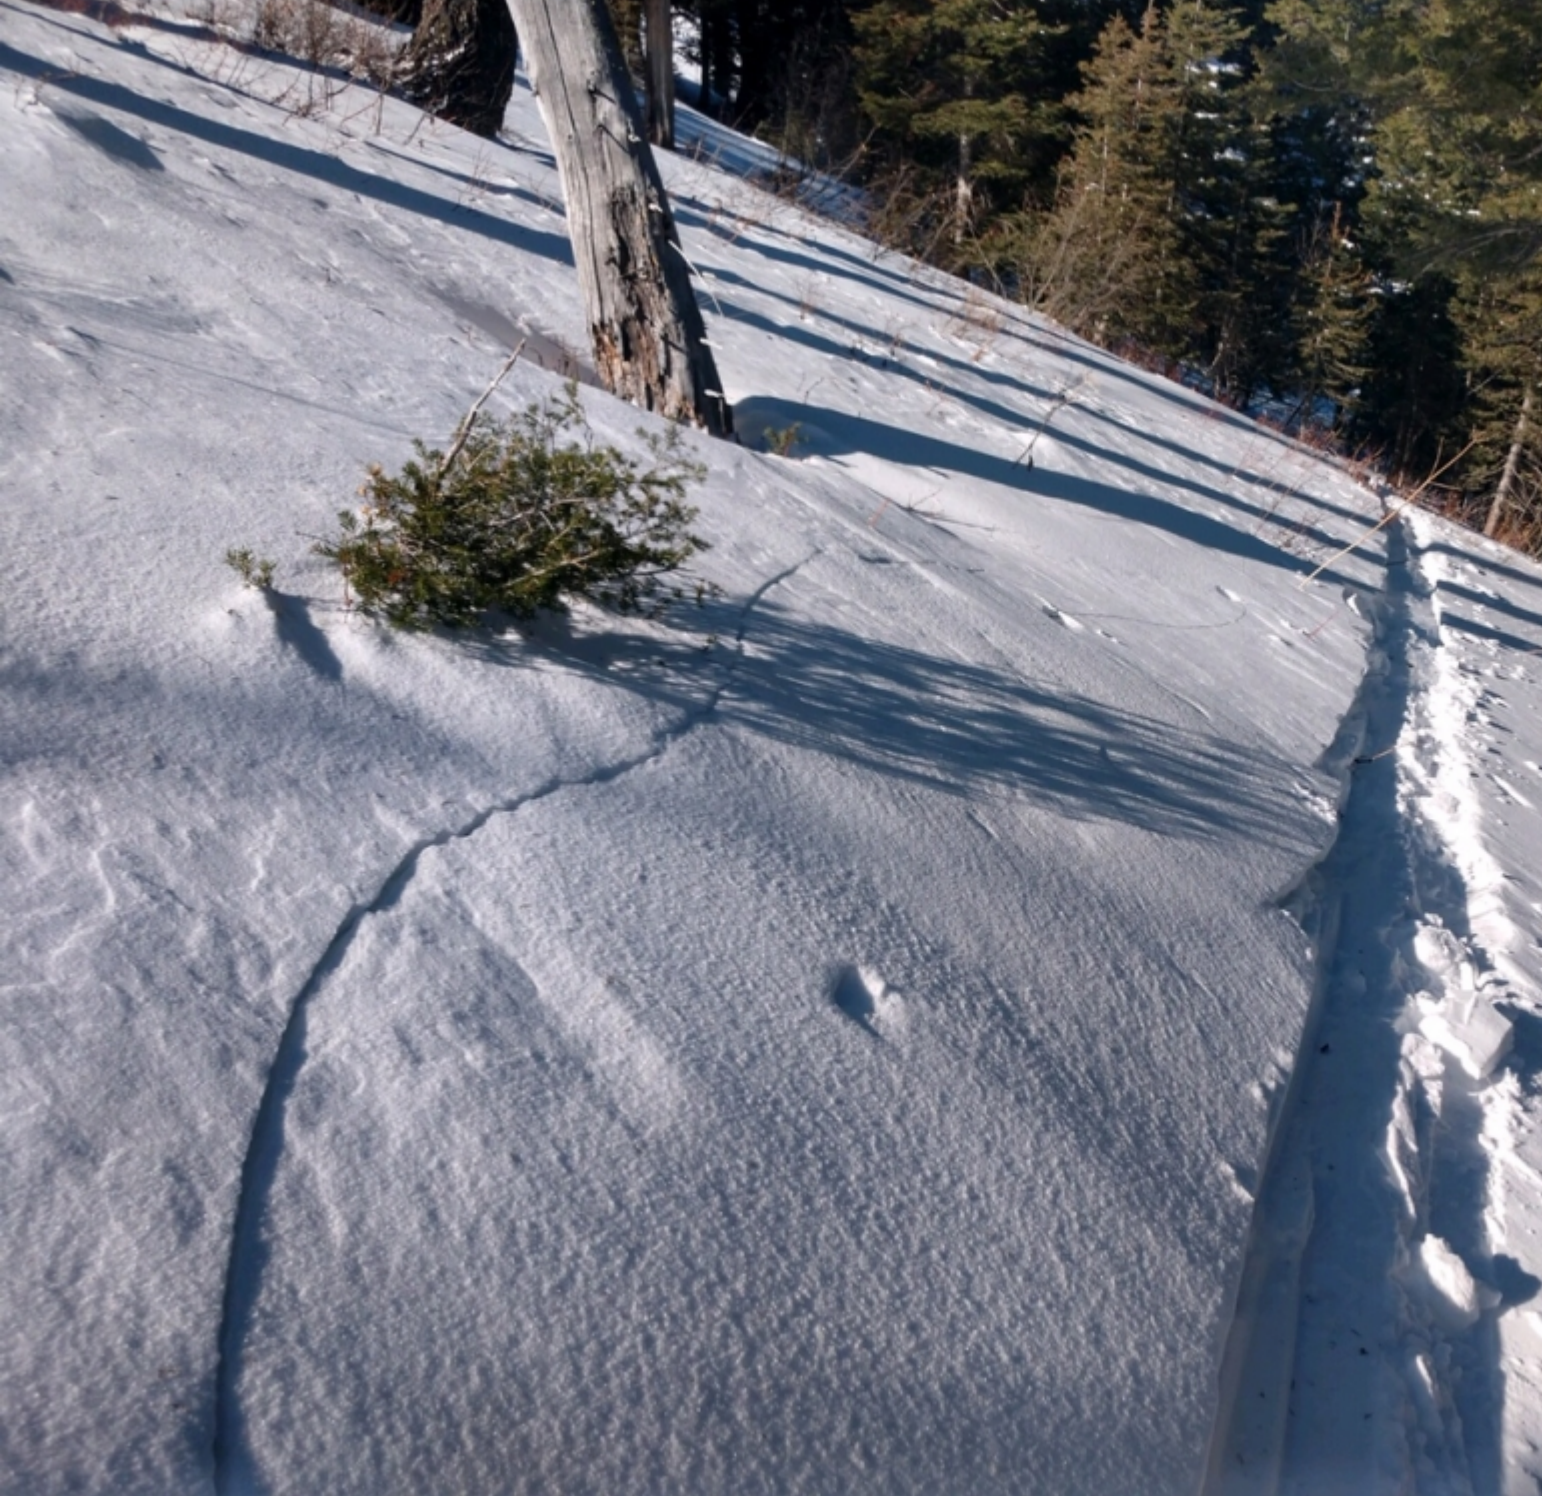
From an email, "...here's a pic from a north facing slope below Thunder Road, about midway up PK. We saw a

few more shooting cracks in the flats below the top of PK, and the surface wind slab where this photo was taken was ~10 cm."
