Unstable ECT n. Bridgers

Bridger Range, 2019-12-09

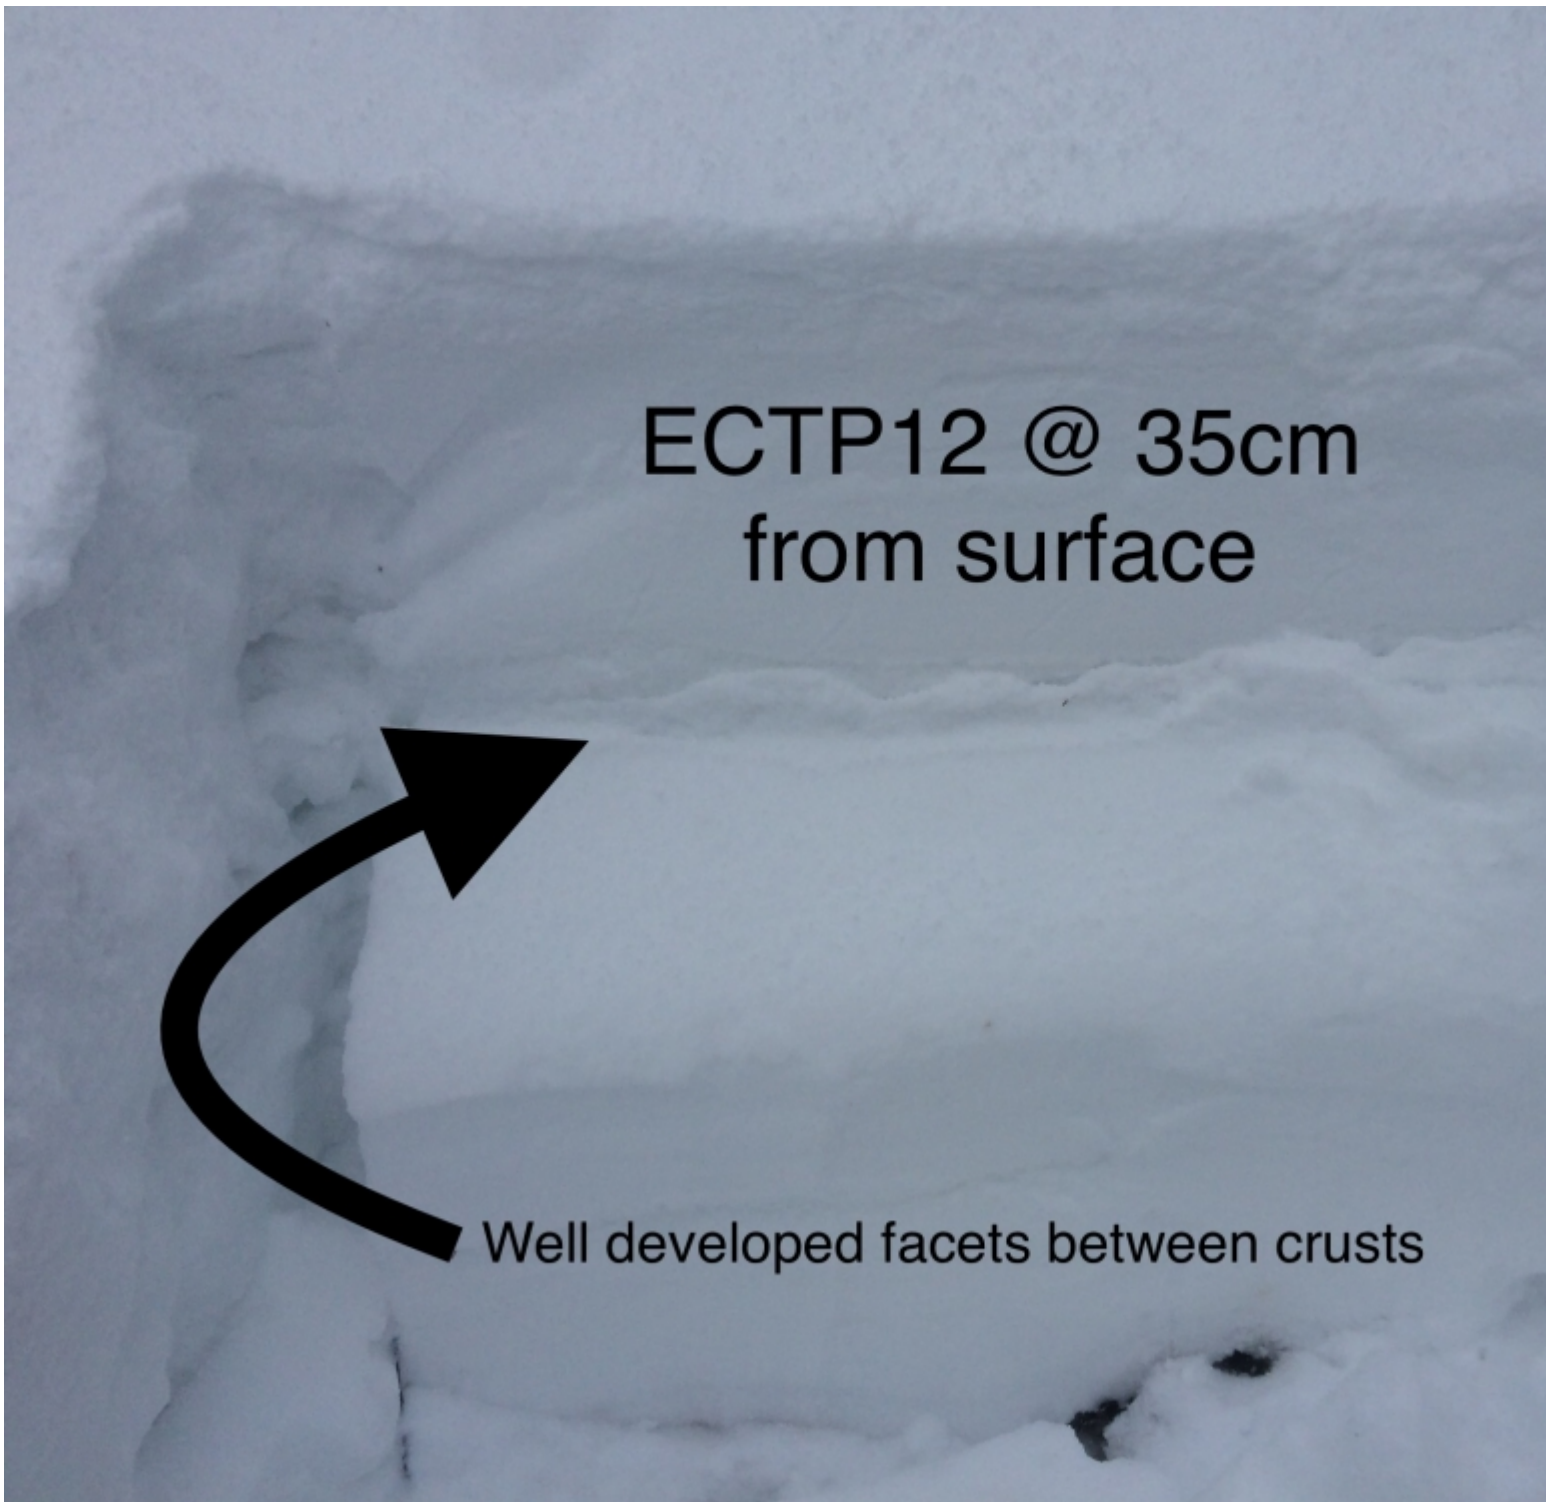
From Obs: "Out poking around the Northern Bridgers today and found some really terrible structure... We dug a couple of pits and both exhibited terrible structure with pronounced facet layers between the most recent pair of melt-freeze and rain crusts.

Results from one of the pits were: 7900' NE aspect 33 degree slope HS95cm (photo included)

- ECTP12@60cm on 2mm well developed facets below most recent M/F crust
- Weak faceted layer is 5cm thick 4F- hardness
- Slab above is a 4F to 1F hardness slab of new graupel and decomposing grains on top of the 1F+ M/F crust..."
