Cracking in drifted snow

Avalanche Details: [Cracking drift in Bridgers](#)

Bridger Range, 2020-12-12

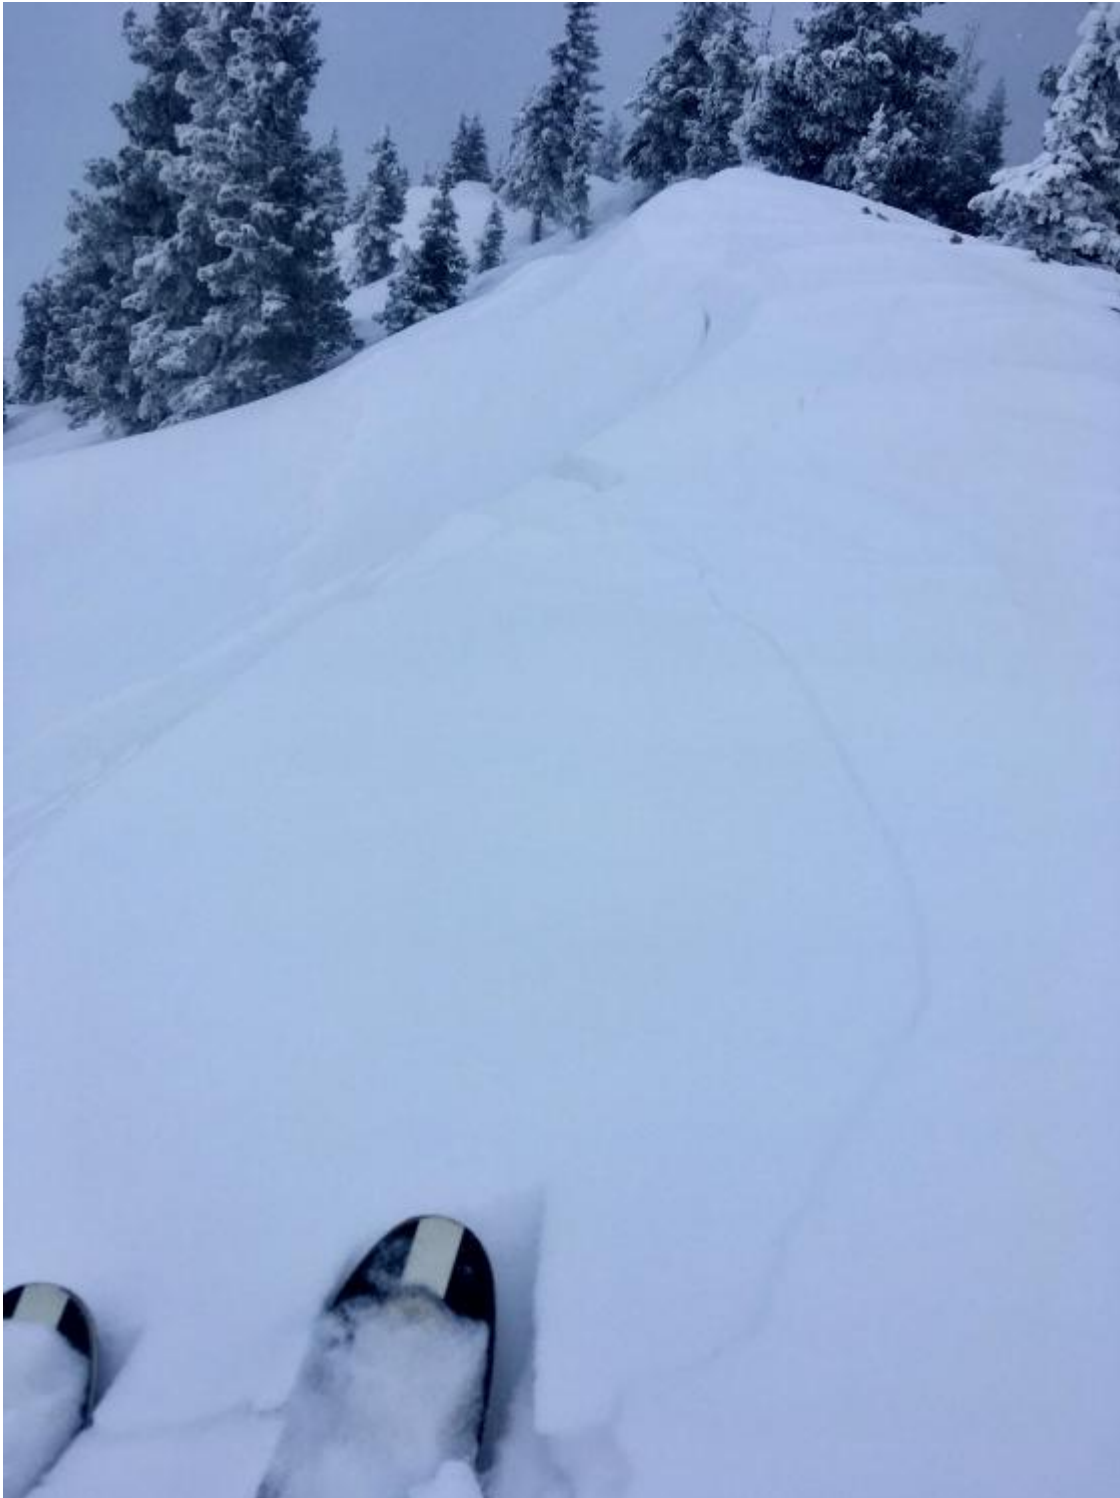
Light wind created soft drifts of new, low density snow near the ridgeline in the Bridger Range. This wind slab easily cracked when touched with skis, 20 feet along the ridge and 5-10 feet down, but didn't slide. This is a sign drifts will be unstable as they grow with more snow and wind. Photo: GNFAAC
