Advisory Region Cooke City Longitude -109.97W Latitude 45.04N Cooke City, 2019-11-24

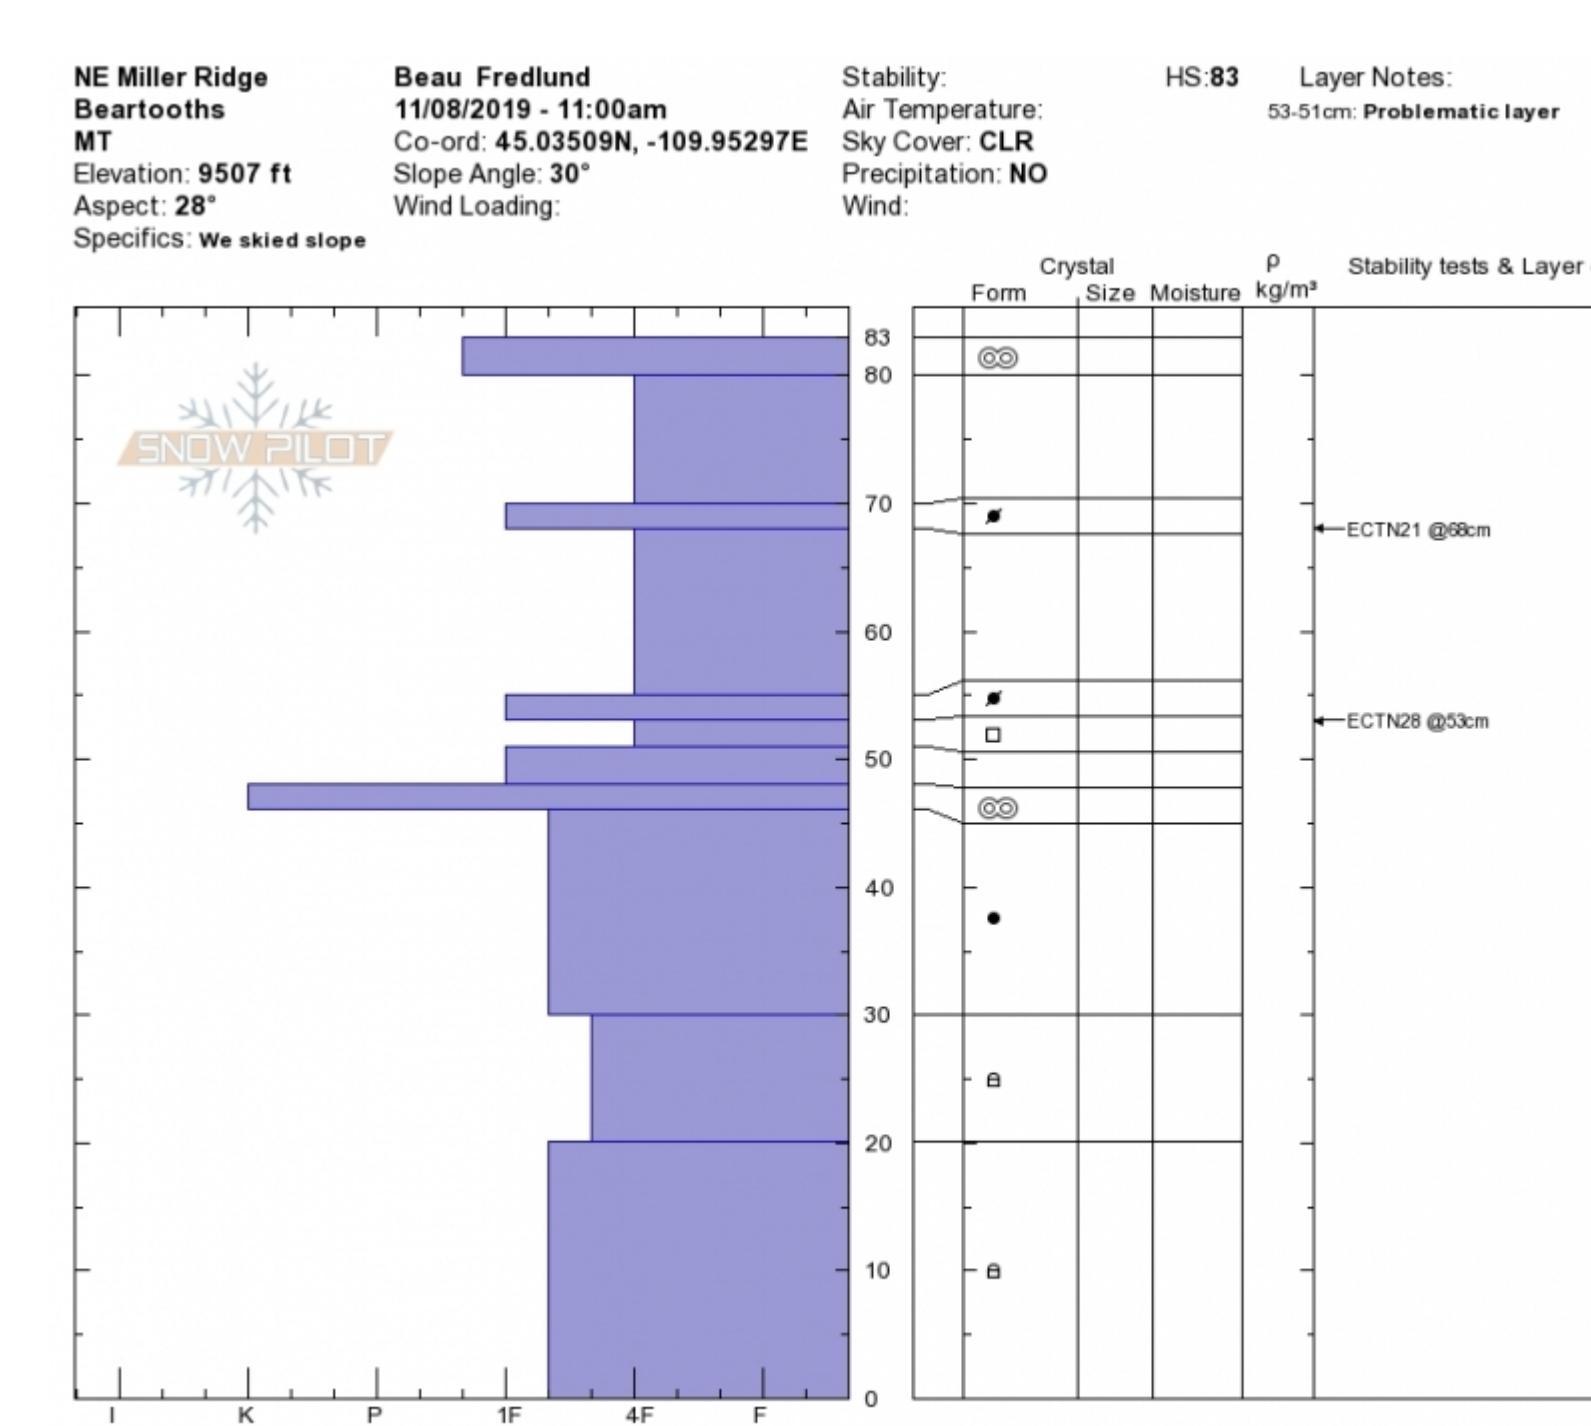
Notes: Some surface hoar found today- mostly in the lower and mid elevations. The upper elevation terrain/above treeline, was general No collapsing nor cracking experienced today.
